TECHNICAL REPORT HL-87-14

WALNUT CREEK FLOOD-CONTROL PROJECT CONTRA COSTA COUNTY, CALIFORNIA

Hydraulic Model Investigation

Final Report

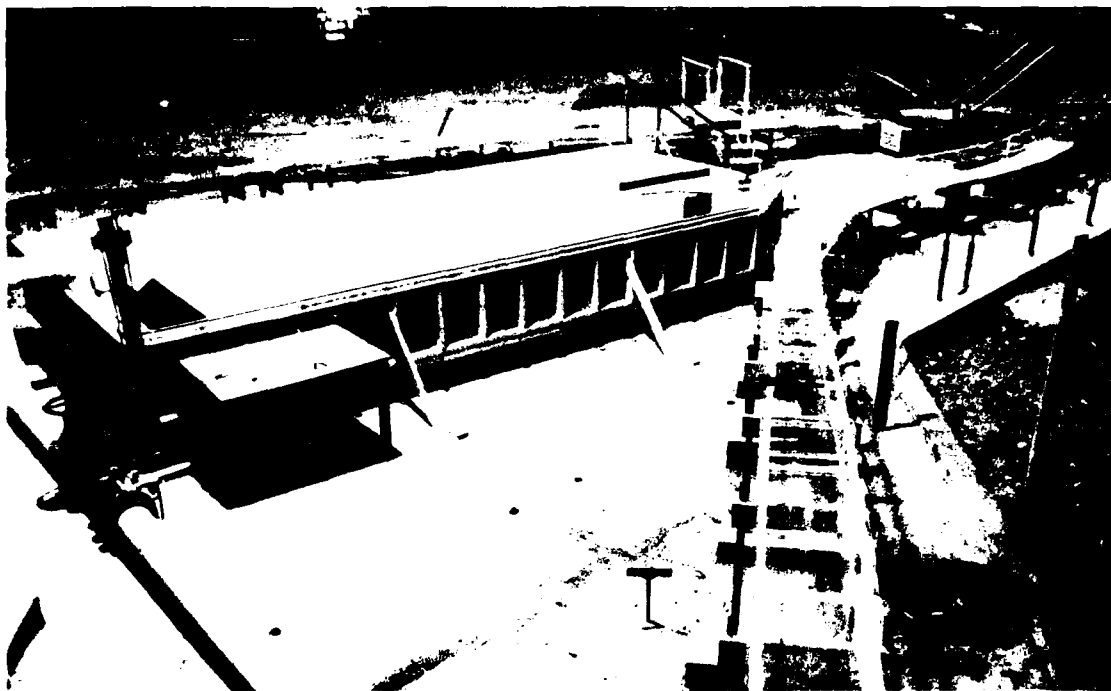
Figure 2. The 1:25-scale model

4. The model, constructed to a scale of 1:25, reproduced approximately 1,084 ft of the San Ramon Bypass Channel, 730 ft of the Walnut Creek channel upstream from the junction, with topography reproduced upstream from the entrance to the revised channel, and 640 ft of the existing Walnut Creek channel downstream from the junction (Figure 2, Plates 1 and 2). The model was constructed of transparent plastic with the invert slopes adjustable to reproduce various energy gradients equivalent to those resulting from different prototype Manning's n roughness factors. Portions of the high-velocity channel requiring superelevation were constructed of concrete with a very smooth finish. The portion of Walnut Creek consisting of natural channel was molded in sand and cement mortar to sheet metal templates.

a. General view

b. Closeup of Walnut Creek-San Ramon junction

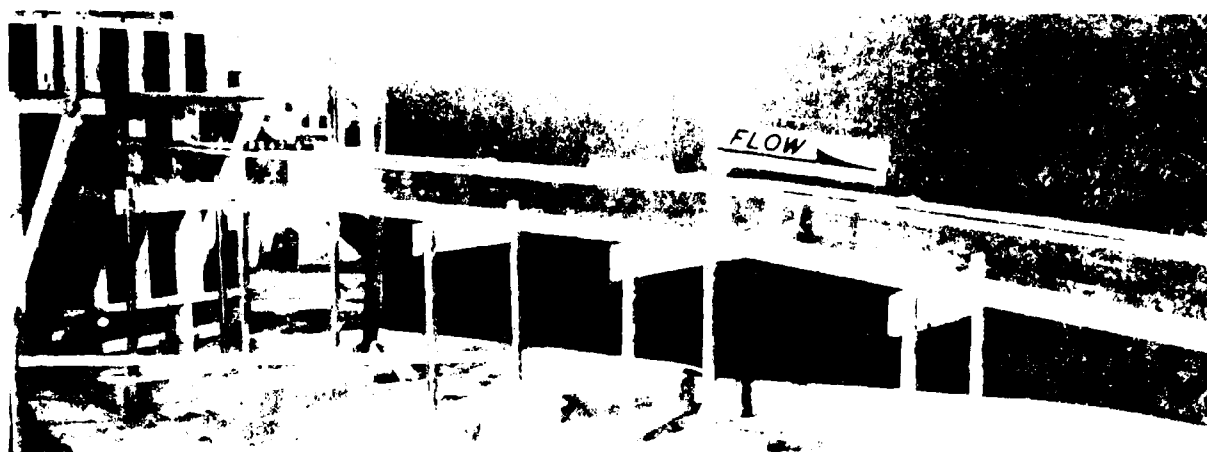
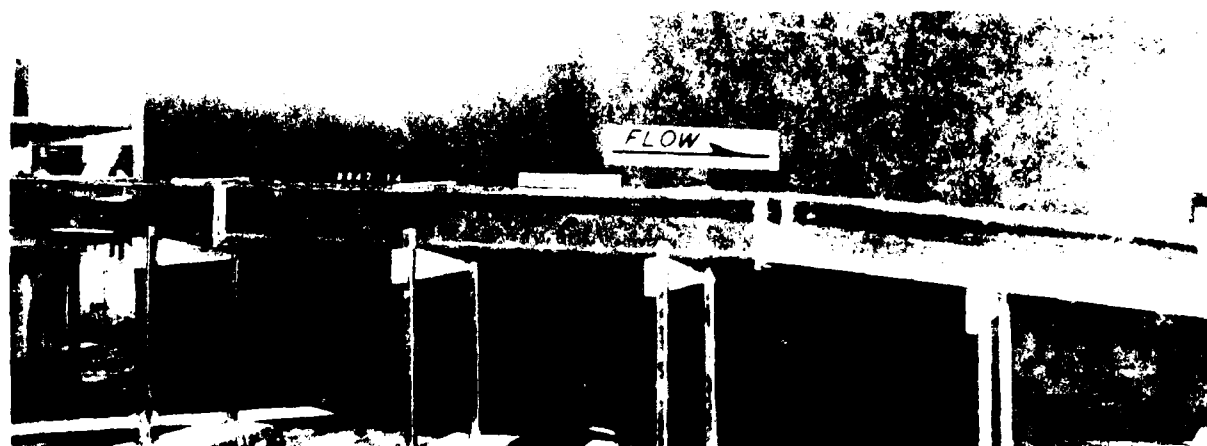
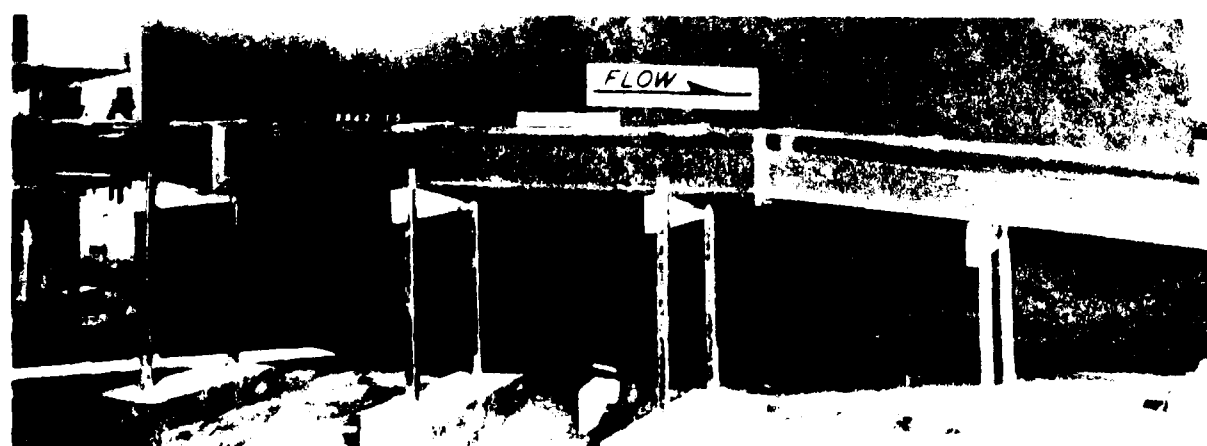
Figure 1. Discharge of water from the canal. The discharge is 11,500 cfs. The water is flowing over the concrete structure.

a. Dry bed

b. Discharge 11,500 cfs

c. Discharge 11,500 cfs

9. The invert slopes of the channels initially tested were adjusted to reproduce an energy gradient resulting from a Manning's n roughness factor of 0.012 in the prototype. Representatives from Office, Chief of Engineers (OCE), US Army, US Army Engineer Division, South Pacific, and US Army Engineer District, Sacramento, inspected the model and observed test runs on 31 January 1984. It was agreed that certain modifications to the model were needed before basic data such as water-surface profiles and photographs of flow conditions were recorded. These modifications included raising the walls near the inlet to the high-velocity channel on Walnut Creek (Plate 3) and placing a low weir in this area. The original design defined herein includes these changes. Water-surface profiles recorded for the 100-year frequency flow Q_{100} conditions in both Walnut Creek and the San Ramon Bypass Channel with the respective maximum concurrent flows are shown in Plates 4 and 5. These flow conditions are shown in Photos 1-6. The black lines shown on the walls of the channels are the proposed wall heights.

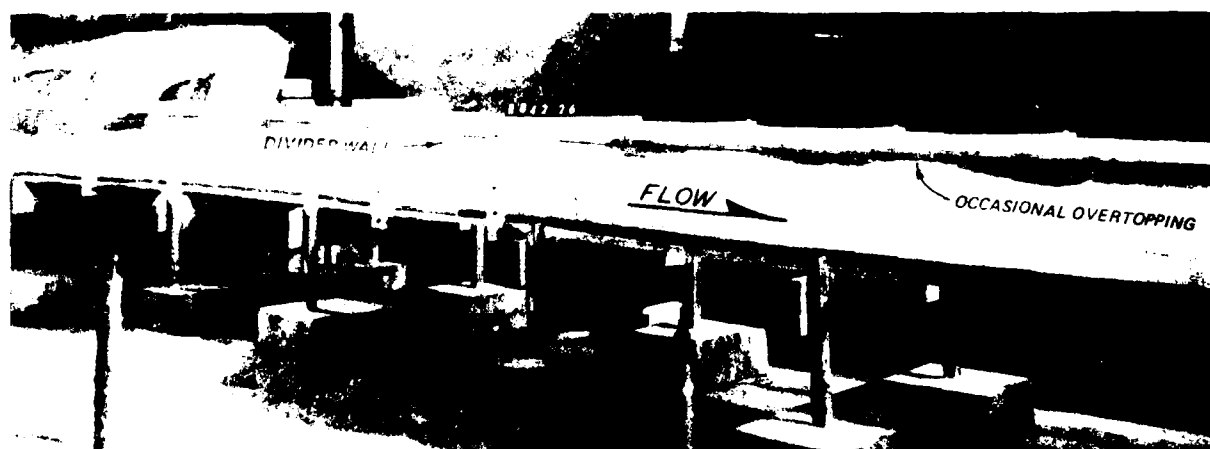
b. Discharge 11,500 cfs in San Ramon
Discharge 10,000 cfs in Walnut Creek

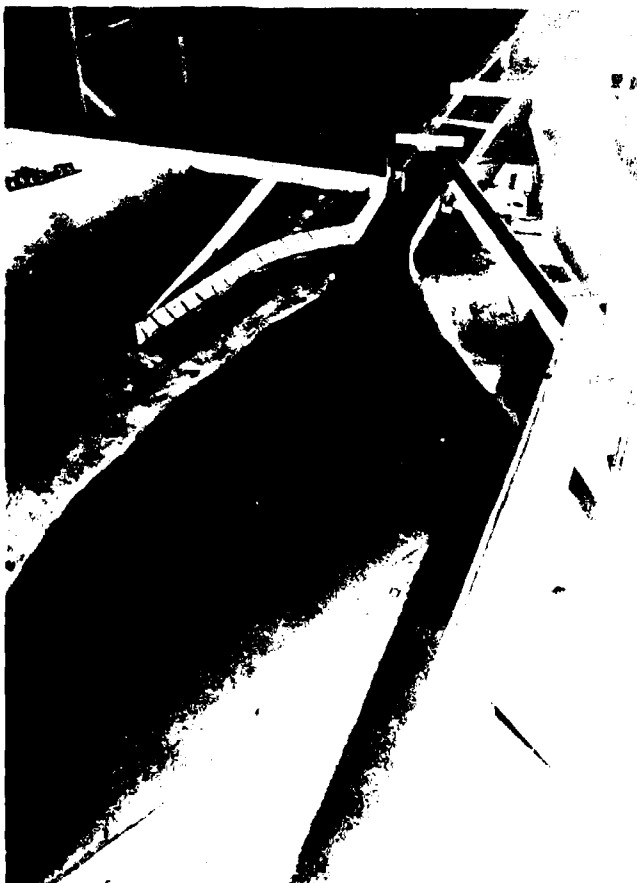
Photo 4. Walnut Creek, looking downstream at the entrance to the velocity channel, on 11/11/67.

b. In channel, bed

10. Satisfactory flow conditions were observed in Walnut Creek upstream from the junction with San Ramon Bypass Channel with discharges less than 7,000 cfs. When the discharge was increased to 7,000 cfs and greater, flow began to enter the channel through the access ramp (Photo 4c). This created unsatisfactory flow conditions which included standing waves that extended downstream to the junction.

26. With a Manning's n value of 0.012 reproduced, entrance conditions into the high-velocity channel on Walnut Creek caused standing waves to develop that extended downstream to the junction due to unsymmetrical approach and inflow into the channel through the access ramp. By blocking off the access ramp, flow conditions and channel efficiency were significantly improved.

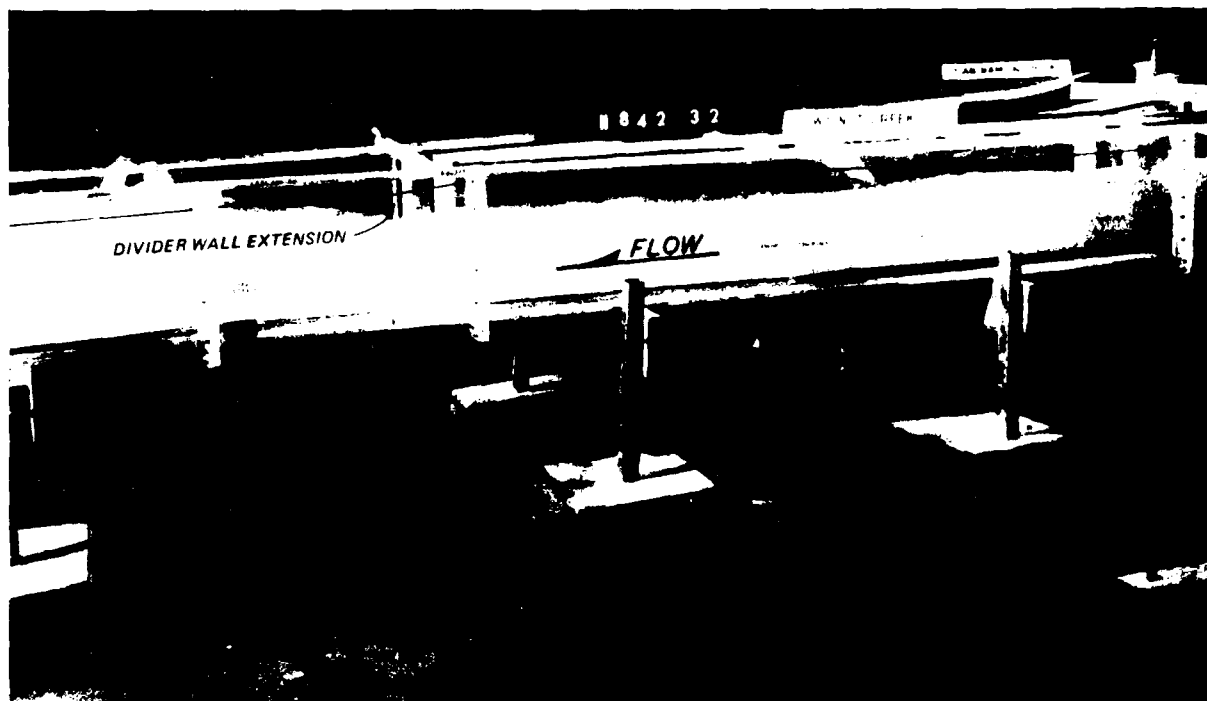
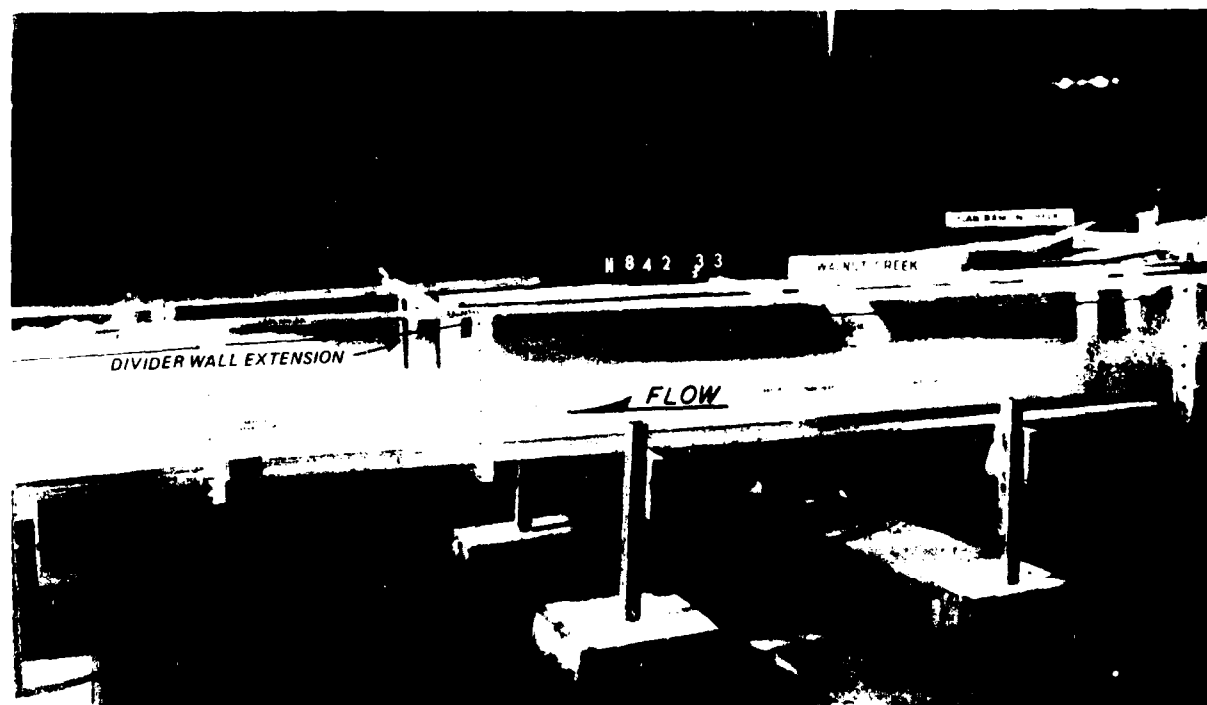
Photo 9. Walnut Creek-San Ramon bypass channel junction, looking in the left side of the channel with the 10-ft divider extension installed, a. and b.

Walnut Creek and the concurrent flow of 11,500 cfs in San Ramon Creek, there was an occasional splashover of flow at sta 581+20, but this was insignificant. Flow conditions were greatly improved in the channel downstream from the divider. The 40-ft-long divider extension was determined to be the optimum length with a Manning's n value of 0.012. Water-surface profiles with various divider extensions are shown in Plates 8-17. Flow conditions are shown in Photos 9-18.

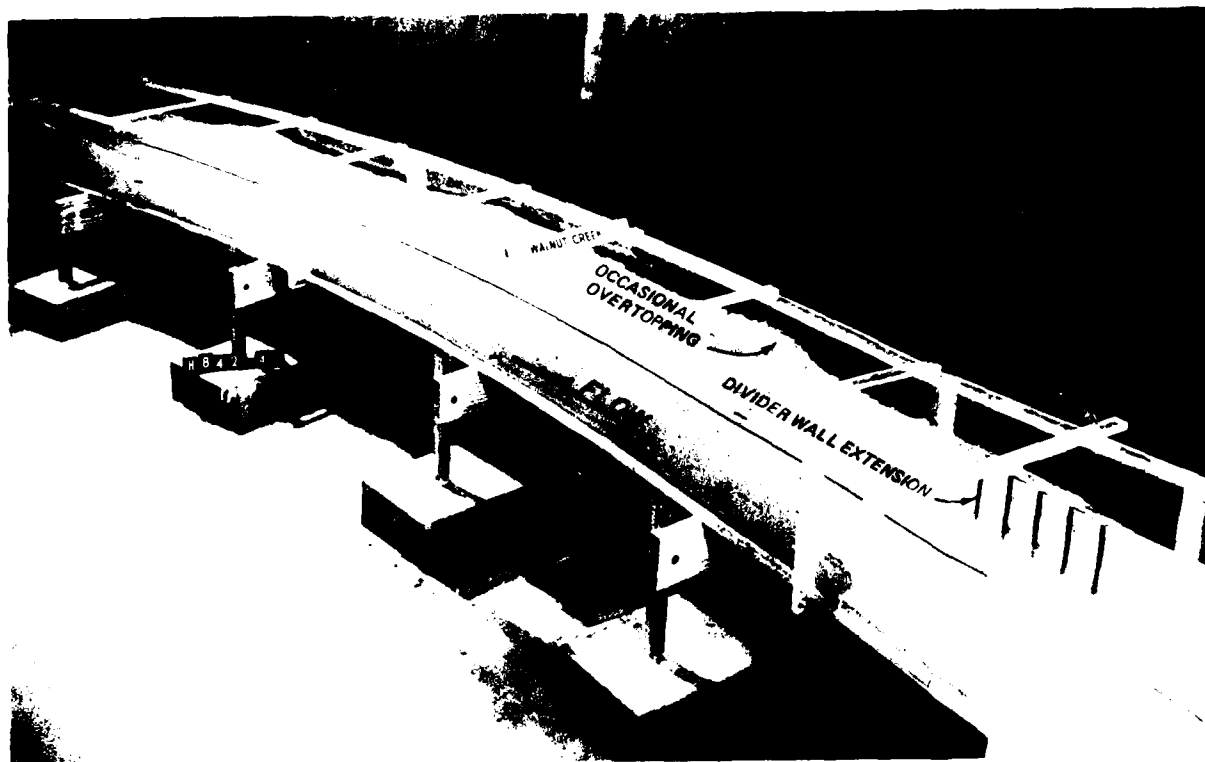
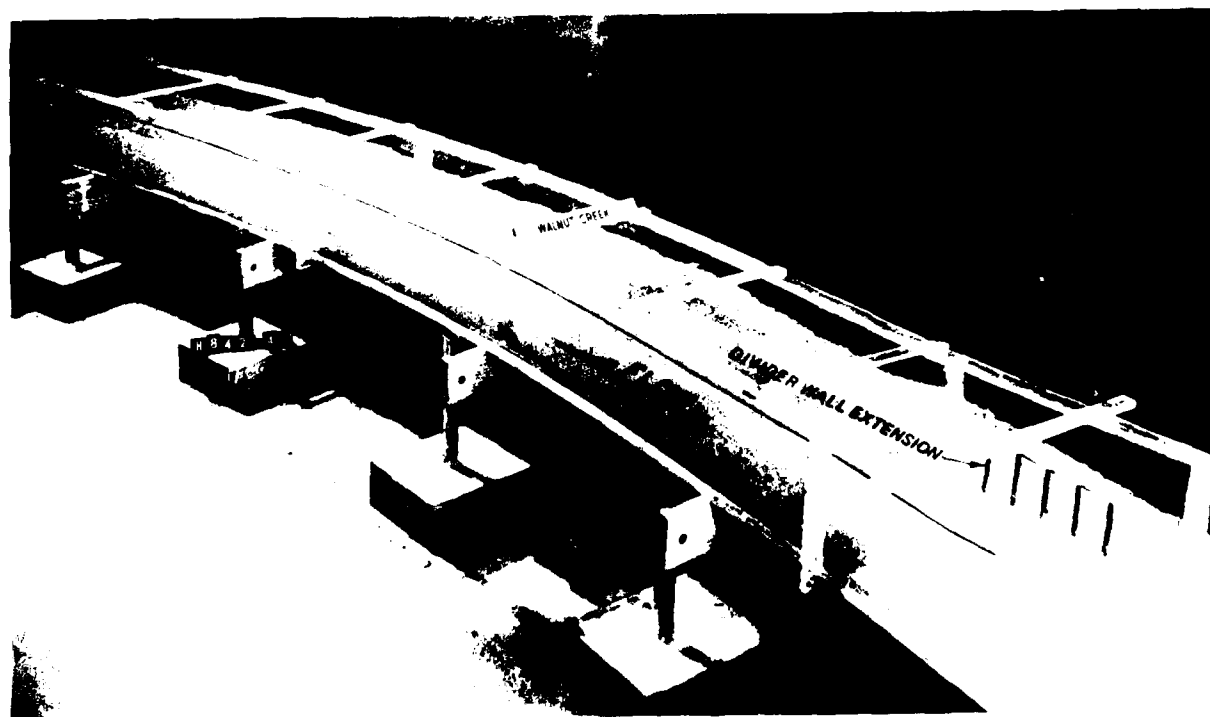
Photo 12. Walnut Creek, looking downstream in the left side of the channel between sta 582+50 and 578+00 with the 30-ft divider extension installed.
 $n = 0.012$

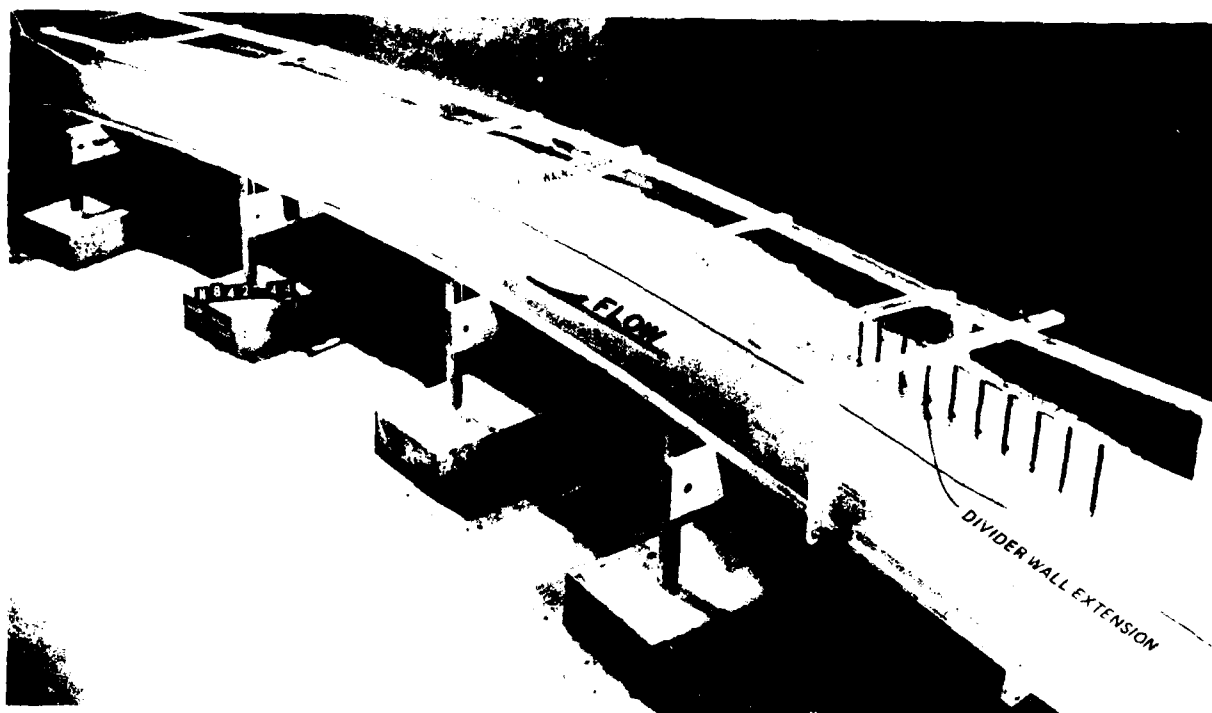
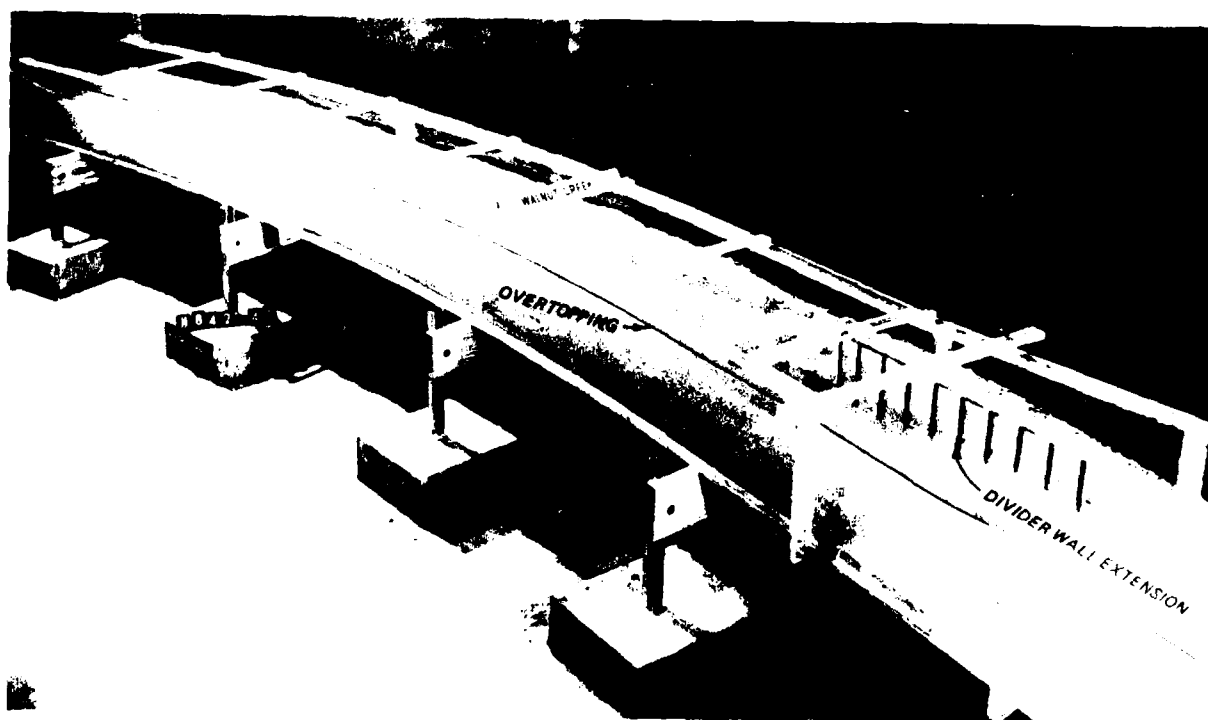
Photo 16. Walnut Creek, looking downstream in the left abutment between sta 582+50 and 578+00 with the 63.8-ft divider extension installed and its nose at 21.25 ft from the left wall, etc.

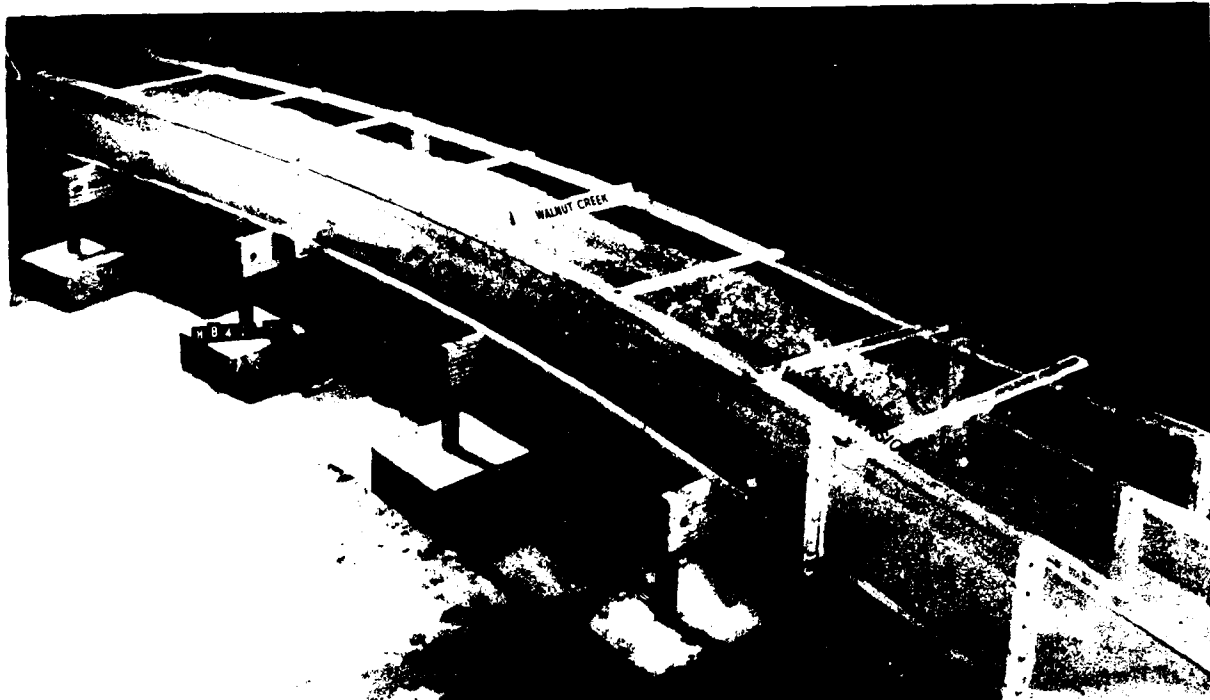
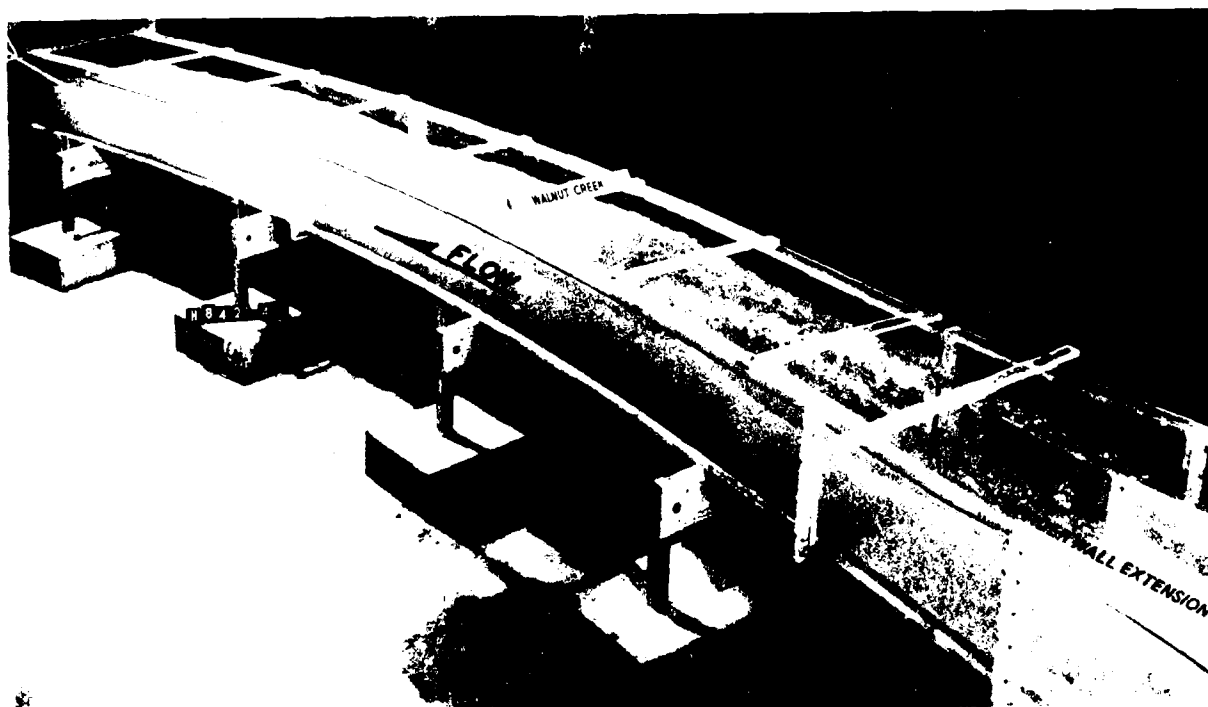
Photo 13. Walnut Creek, looking downstream in the left side of the channel between sta 582+50 and 578+00 with the 40-ft divider extension installed, $n = 0.012$

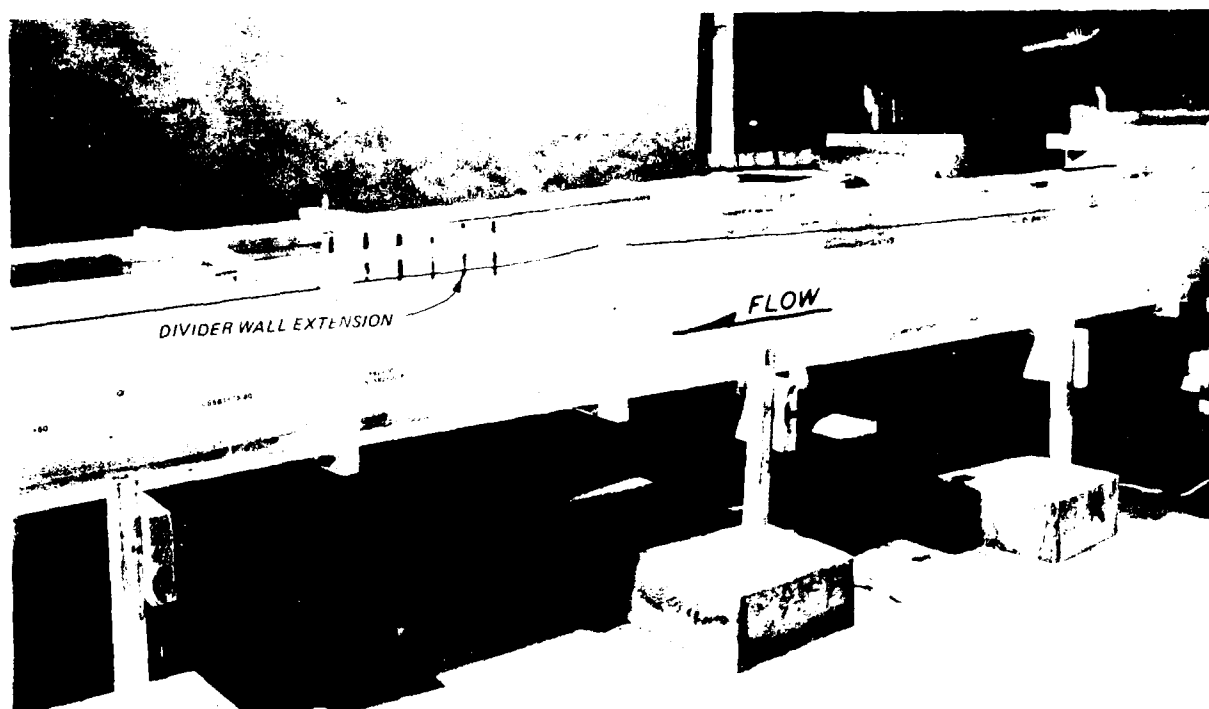
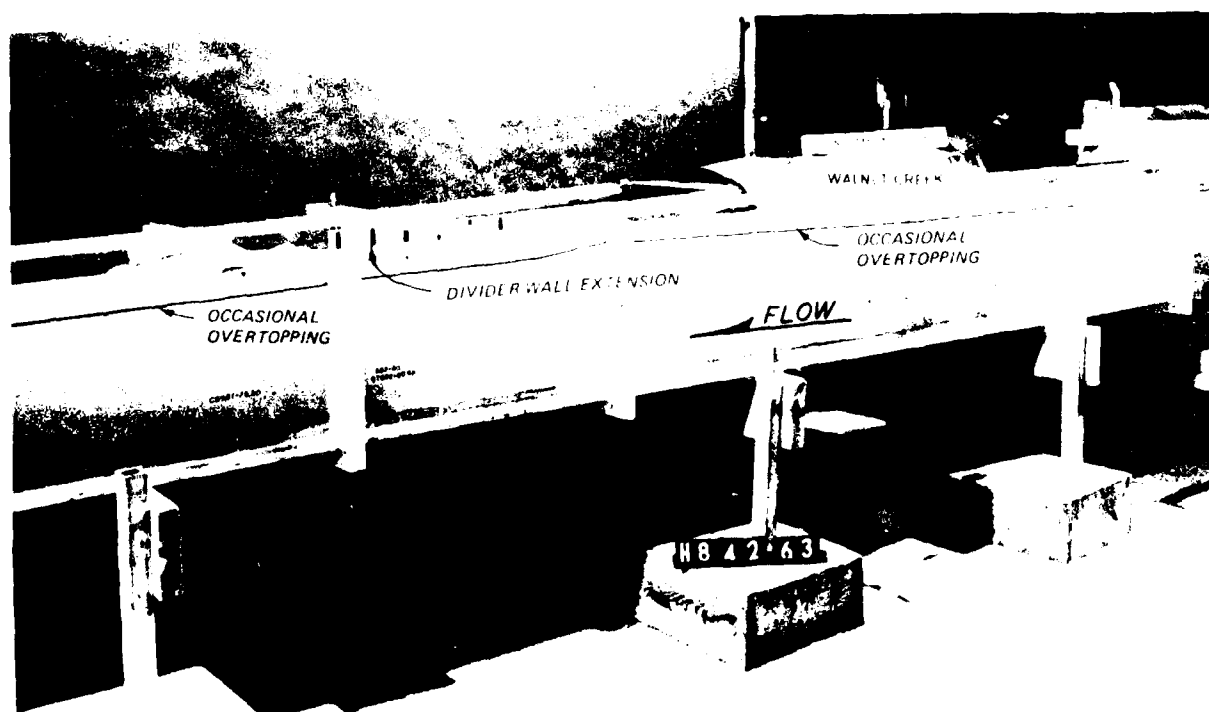
Photo 17. Walnut Creek-San Ramon Express Tunnel junction, looking
in the left side of the channel with the 40-ft divider extension
installed, $q = 0.214$

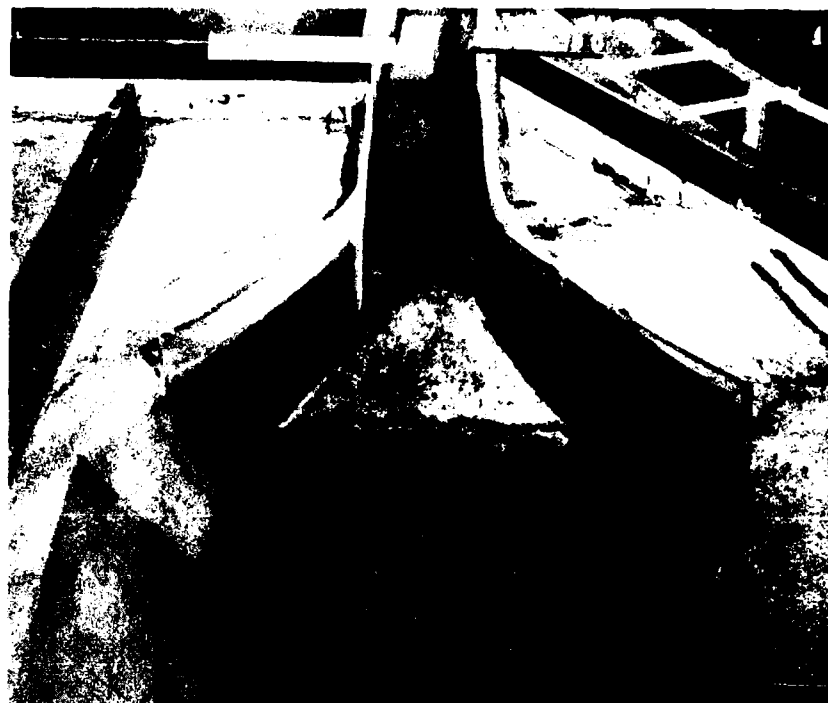
Photo 22. Walnut Creek, looking downstream at the entrance to the high-velocity channel with the symmetrical entrance (Continued)

c. Discharge 10,000 cfs, confetti accents surface flow patterns; exposure time 10 sec (prototype)

and photographs of flow conditions in the approach channel are shown in Plate 25 and Photo 22, respectively. Since the streamlined left wall entrance decreased the water surface only by 0.1 ft, and would involve major structural modifications, it would not be feasible to incorporate this modification into the design.

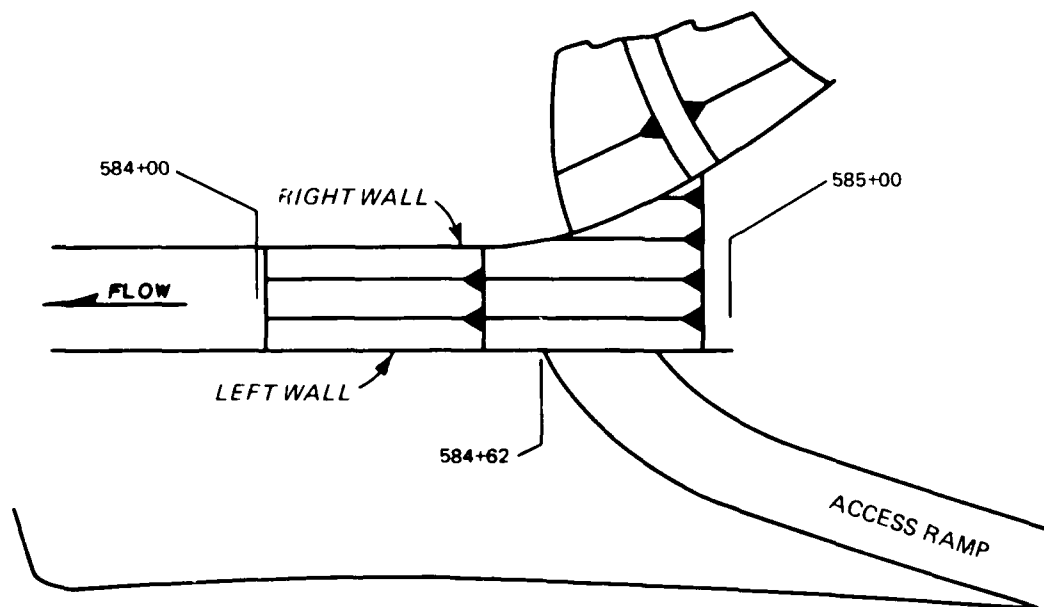
DETAILS OF RAISED WALL HEIGHT
ACCESS RAMP BRIDGED

11. At the upstream end of the concrete channel in Walnut Creek, a wall was installed which bridged the access ramp (Photo 7a, Plate 6) in an effort to improve flow conditions with discharges greater than 7,000 cfs. With this modification, flow conditions were significantly improved in the portion of Walnut Creek upstream from the junction with discharges greater than 7,000 cfs.

22. The overall recommended design determined from test results for a Manning's n of 0.012 incorporates into the original proposed design raising the walls near the inlet to the high-velocity channel on Walnut Creek (Plate 3), bridging the access ramp (Plate 6), and lengthening the divider extension to 40 ft.

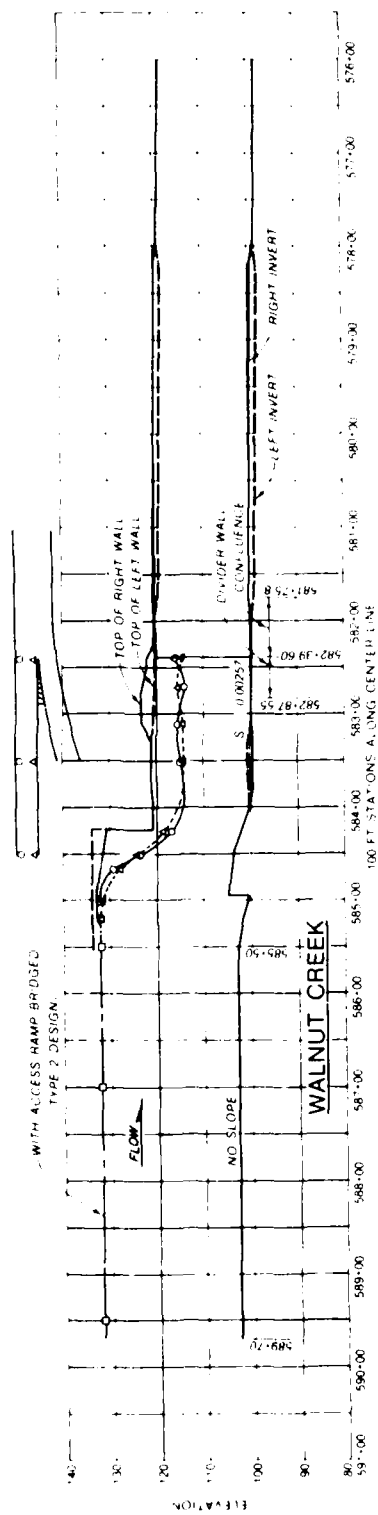
WATER-SURFACE PROFILES

WALNUT CREEK (Q_{100}) 10,000 cfs

SAN RAMON CREEK 11,500 cfs

ACCESS RAMP BRIDGED

Water-surface profiles recorded with the 100-year frequency discharge in Walnut Creek of 10,000 cfs and the maximum concurrent discharge in the San Ramon Bypass Channel are shown in Plate 7. Flow conditions with this modification are shown in Photos 7b and 8.

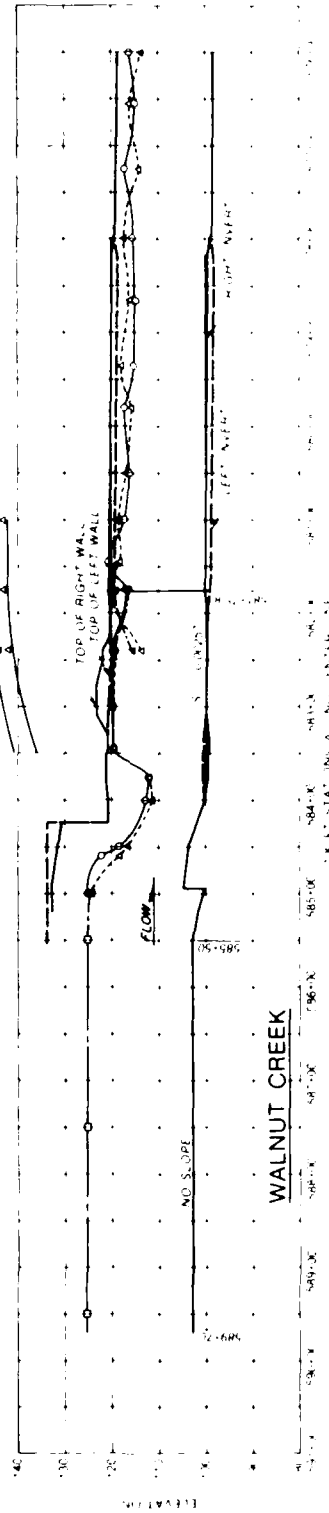
WATER-SURFACE PROFILES

WALNUT CREEK	6,800 cfs
SAN RAMON CREEK (Q ₁₀)	15,200 cfs
63.8-FT DIVIDER EXTENSION	
NOSE AT 21.25 FT	
ACCESS RAMP BRIDGED	
n = 0.012

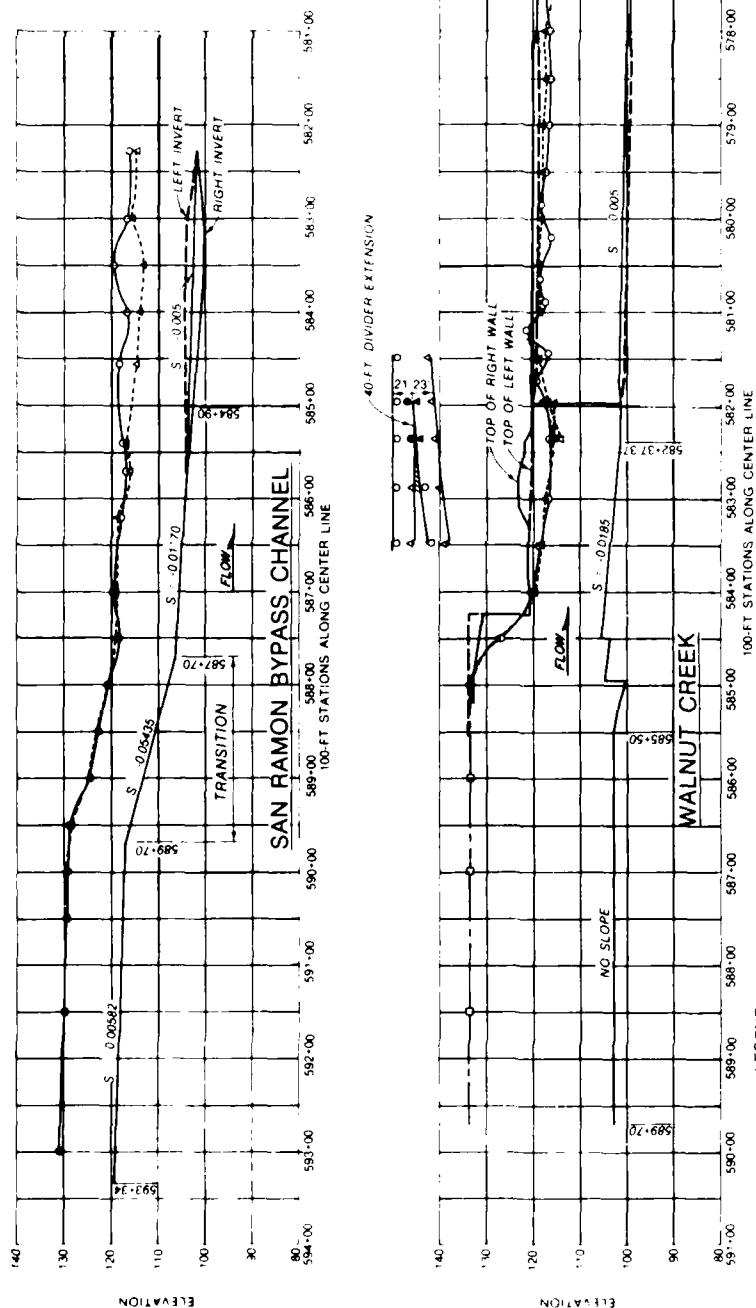
WATER-SURFACE PROFILES

WALNUT CREEK (Q_{100}) 10,000 cfs

SAN RAMON CREEK 11,500 cfs

40-FT DIVIDER EXTENSION

TYPE 2 DESIGN CHANNEL

19. Water-surface profiles measured with the type 2 design channel for the 100-year frequency flow conditions in both Walnut Creek and the San Ramon Bypass Channels with respective maximum concurrent flows are shown in Plates 21 and 22. These flow conditions are shown in Photo 21. Satisfactory flow conditions were observed in the San Ramon Bypass Channel for all discharges tested. With the design flow of 15,200 cfs in the San Ramon Bypass Channel and a concurrent flow of 6,800 cfs in Walnut Creek, a hydraulic jump formed in the Walnut Creek channel upstream from the junction which occasionally overtopped the wall by 1 to 2 ft between sta 583+20 and 581+50, as shown in Plate 21 and Photo 21b. With the design flow of 10,000 cfs in Walnut Creek and a concurrent flow of 11,500 cfs in the San Ramon Bypass Channel, flow exceeded the wall heights by 1.5 ft maximum at sta 581+20, as shown in Plate 22 and Photo 21a.

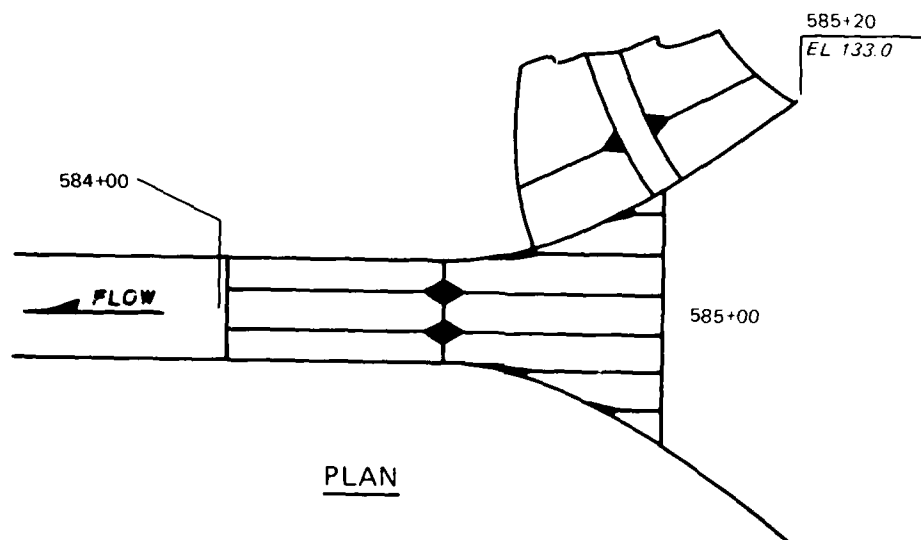
SYMMETRICAL
ENTRANCE

WALNUT CREEK (Q ₁₀₀)	10,000 cfs
SAN RAMON CREEK	11,500 cfs

SYMMETRICAL ENTRANCE
 $\eta = 0.014$
